**KOOTENAI DEVELOPMENT IMPOUNDMENT DAM**

**AUGUST 2011 ROUTINE OWNERS INSPECTION**

Prepared by: Kurt Hafferman, P.E.

Inspection Date: August 25<sup>th</sup>, 2011  
Report Date: December 29, 2011

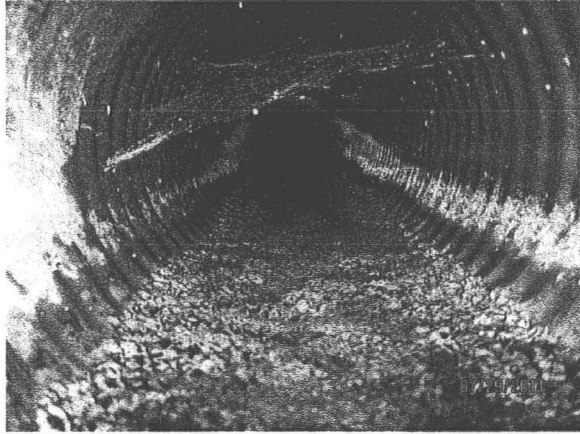
**Figure 6: Drain 3 July 2011 vs. August 2011**

There terminal end of drain 3 is located 128.5 feet in from the toe of the dam and closely matches the location of the cross drain shown in the Phase 1 inspection report by Morrison and Maierle, Inc. It may be possible that the flow entering drain 3 perpendicular may be an indication that drain 3 is located at the Phase 1 cross drain location. It is also speculated that the cross drain could be the source of gravel during the high flow events. As discussed, last month a noticeable increase of material at the outlet of drain 3 was discovered as compared to pre-spring runoff; which prompted the video inspection. This month the material has washed out of the drain and there is no apparent gravel transport and flows have returned to normal levels and are shown in figure 6 below.

Flume 1-4 also showed material buildup in the flume bottom and is likely a result of material transported from drain 3. The flume bottom was cleaned to monitor future buildup. Drain 5 is still sustaining higher flows than normal and also peaked at record levels this spring. Cleaning around the weir shows that there was also fine grain dark sediment material transported out of this drain. Sediment depth was measured behind the weir to monitor future transport of material.

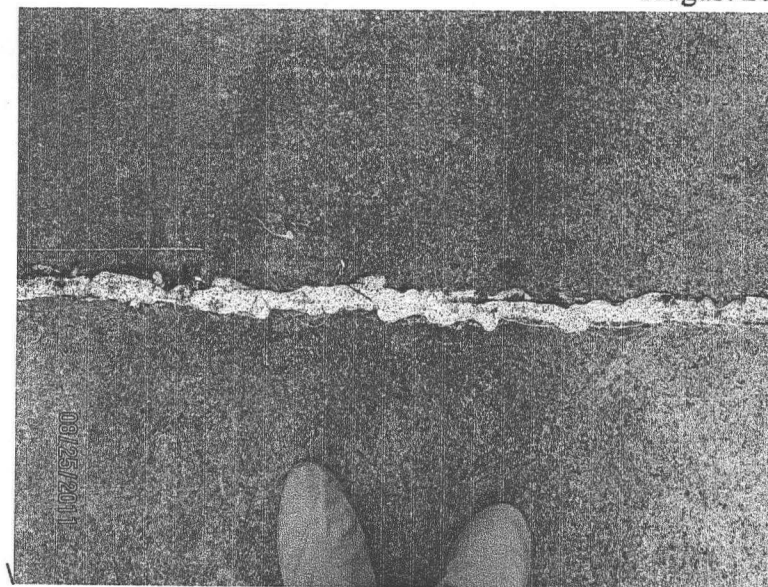
Concrete Joint Repair

Chapman Construction has now completed expansion joint maintenance in the Principal Spillway after sustained flows resulted in some of the joint epoxy lifting out. The loose joint epoxy was removed and the joint cleaned prior to re-sealing.

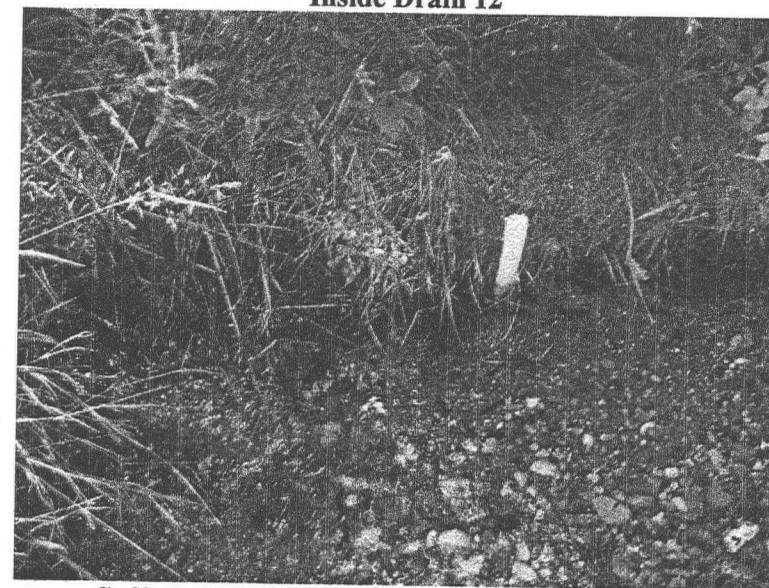
**Sediment Monitoring Station at Drain 12 Outlet**

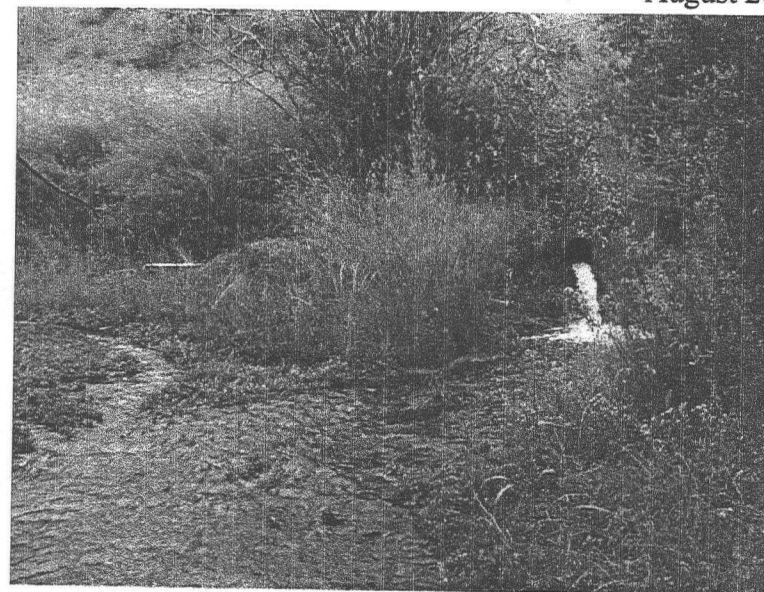
**Converging Flows below Drain 6**

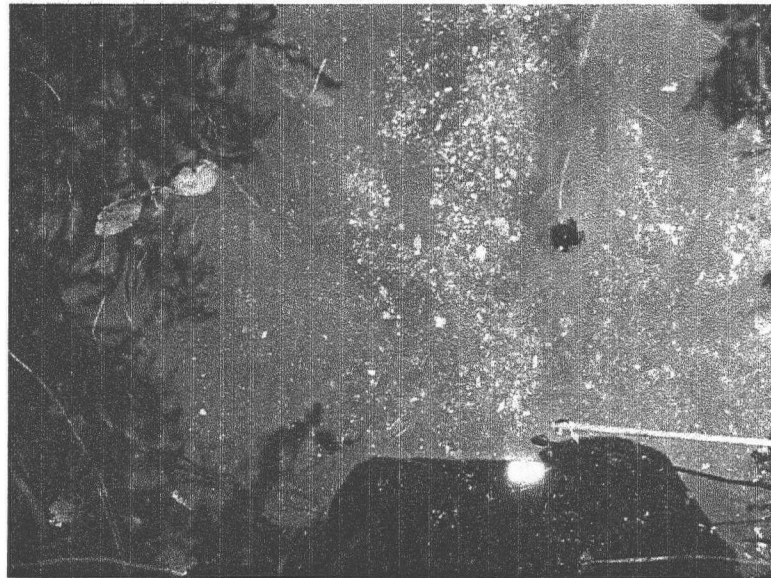
**Sediment behind Weir 5**
